MICROMECHANISMS OF FATIGUE CRACK GROWTH AND FRACTURE TOUGHNESS IN METAL MATRIX COMPOSITES

Interim Technical Report

FRACTURE SURFACE ROUGHNESS AS A GAUGE OF FRACTURE TOUGHNESS:
ALUMINUM-PARTICULATE SiC COMPOSITES

D. L. Davidson
Southwest Research Institute
6220 Culebra Road
San Antonio, TX 78284

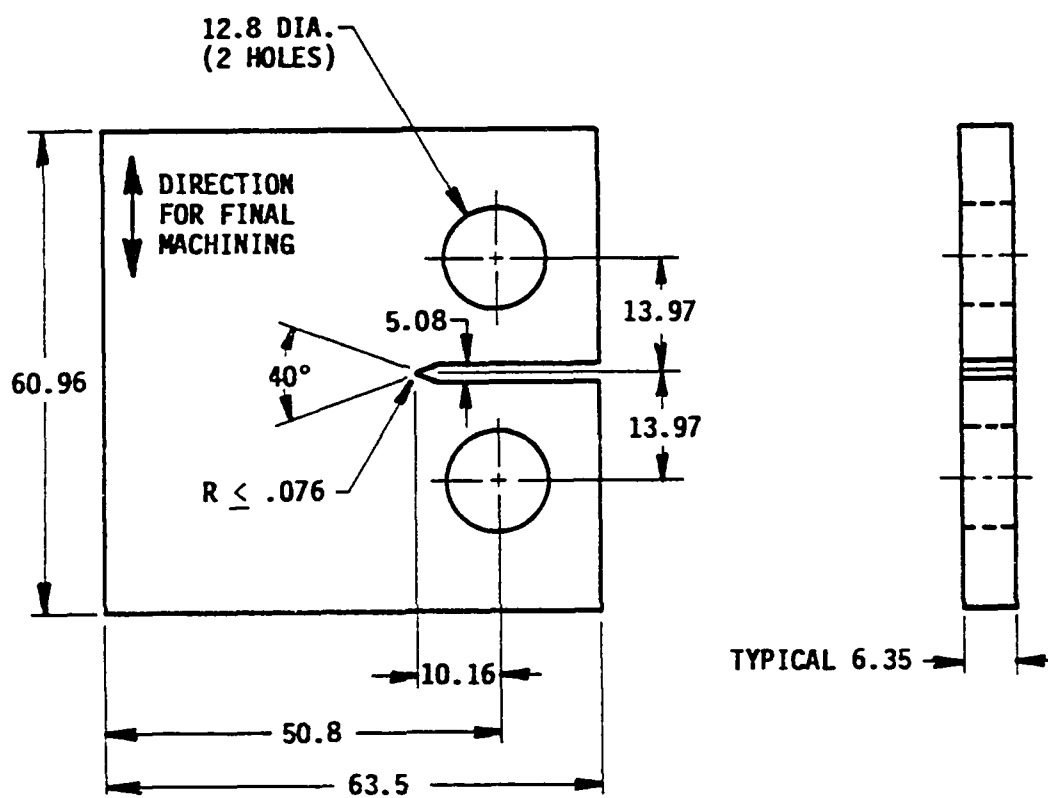
Fig. 1. Design and dimensions, in mm, of the specimens used for the measurement of fracture toughness.

Compact-tension specimens of the dimensions shown in Fig. 1 were tested. After heat treatment, specimen blanks were machined to finished dimensions. These specimens were then further polished using metallurgical specimen preparation techniques.

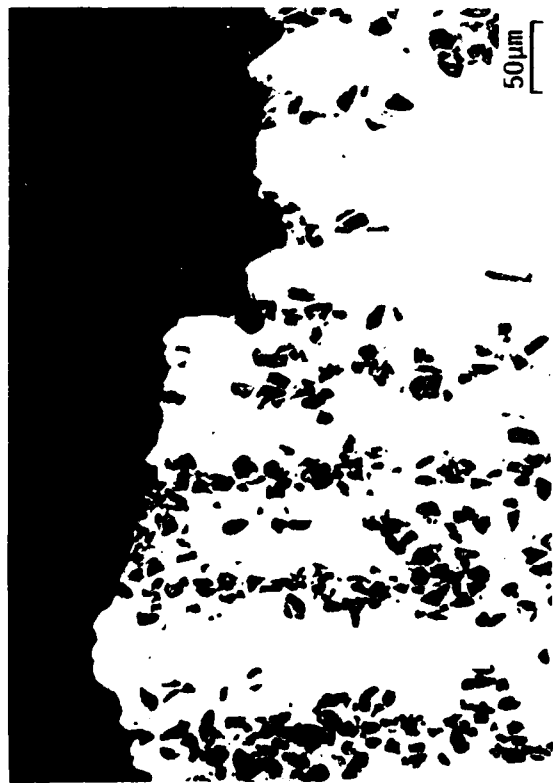
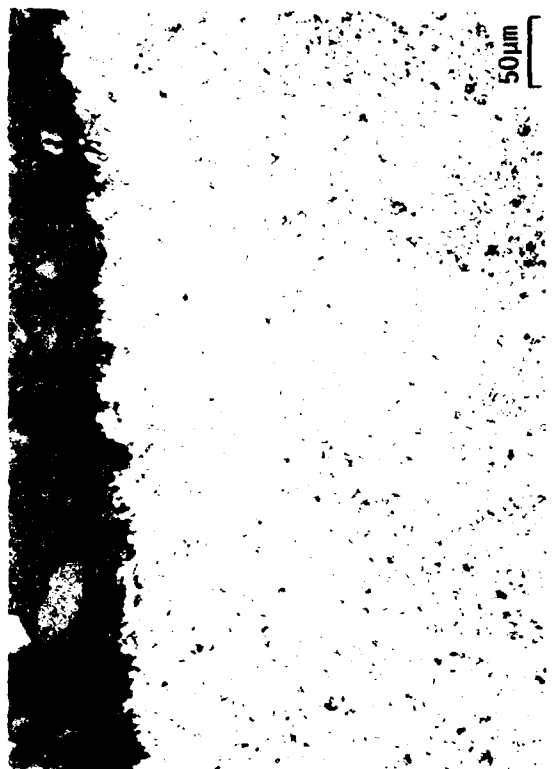
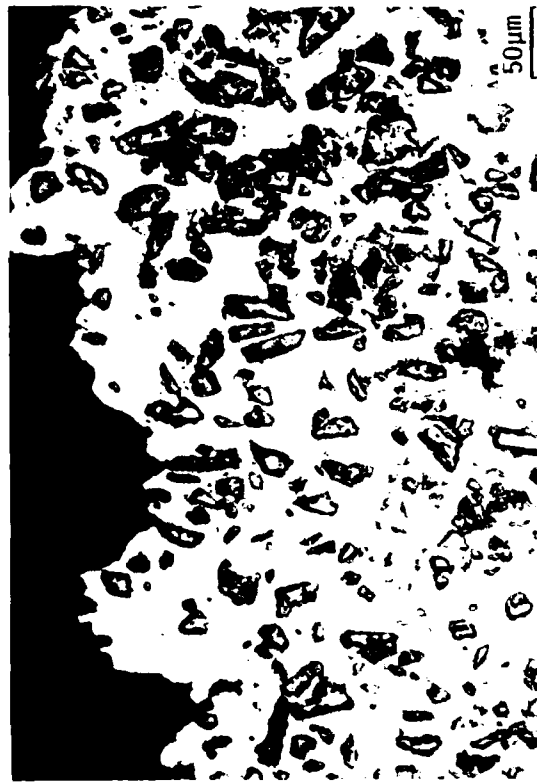
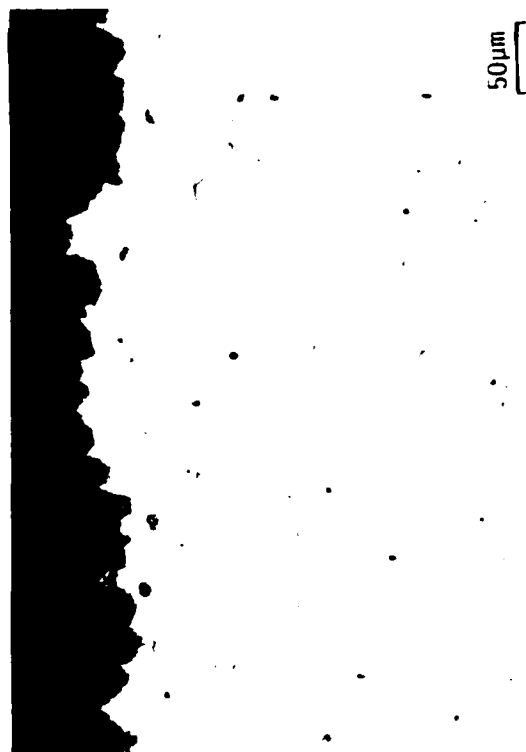
(a) 2014 + 15 v/o SiC PA
 $R_S(0) = 2.26$

(b) IN - 9021 + 14 v/o SiC PA
 $R_S(0) = 2.34$

(c) 2014 + 25 v/o SiC PA
 $R_S(0) = 2.49$

(d) 2024-T351
 $R_S(0) = 1.69$

Fig. 2. Examples of fast fracture surface profiles from which roughness values were measured. Crack growth direction was left to right. The differences in SiC size and distribution are obvious, but the similarity in surface roughness between (a) and (b) are not. See Tables 3 and 5.

Fracture Surface Roughness: Some examples of cross-sectional views through fast fracture zones of the fracture toughness specimens are shown in Fig. 2. The mechanically alloyed material clearly has much finer average size SiC than that made by casting. Also the distribution of SiC is more uniform in the mechanically alloyed material. Increasing volume fraction of SiC increases the uniformity of distribution, Fig. 2(c).

Once surface profiles of the fast fracture region were digitized from photographs such as shown in Fig. 2, the image processing system determined values of the roughness parameter R_L with increasing values of the measuring unit (η). From these values of R_L , eq. (2) was used to compute R_S . Resulting roughness values for the fracture surfaces shown in Fig. 2 are given in Table 2.

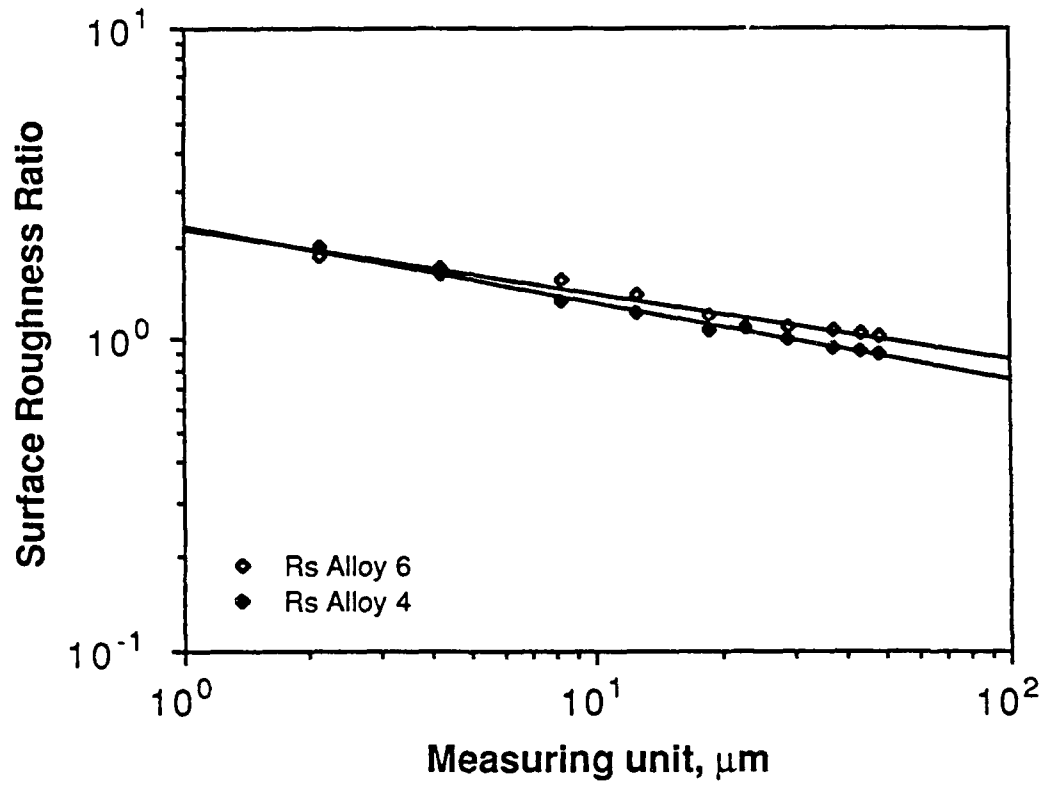
Fig. 3. Surface Roughness Ratio parameters as a function of the measuring unit for two of the composites showing the similarity in magnitude of Rs and the linearity of the relationship when plotted this way.

The exponent of eq. (6) is also the slope of the lines in Figs. 3 and 4.

The results of Figs. 3 and 4 indicate the data are fit reasonably well by eq. (6), over the range of n for which measurements were made, $2.12 < n < 48.1 \mu\text{m}$. Even the one case where much smaller values of n were investigated showed a good fit. Thus, the results of this investigation indicate that a fractal dimension does describe fracture surface profiles of these SiC reinforced composites, and unreinforced 2024-T351.

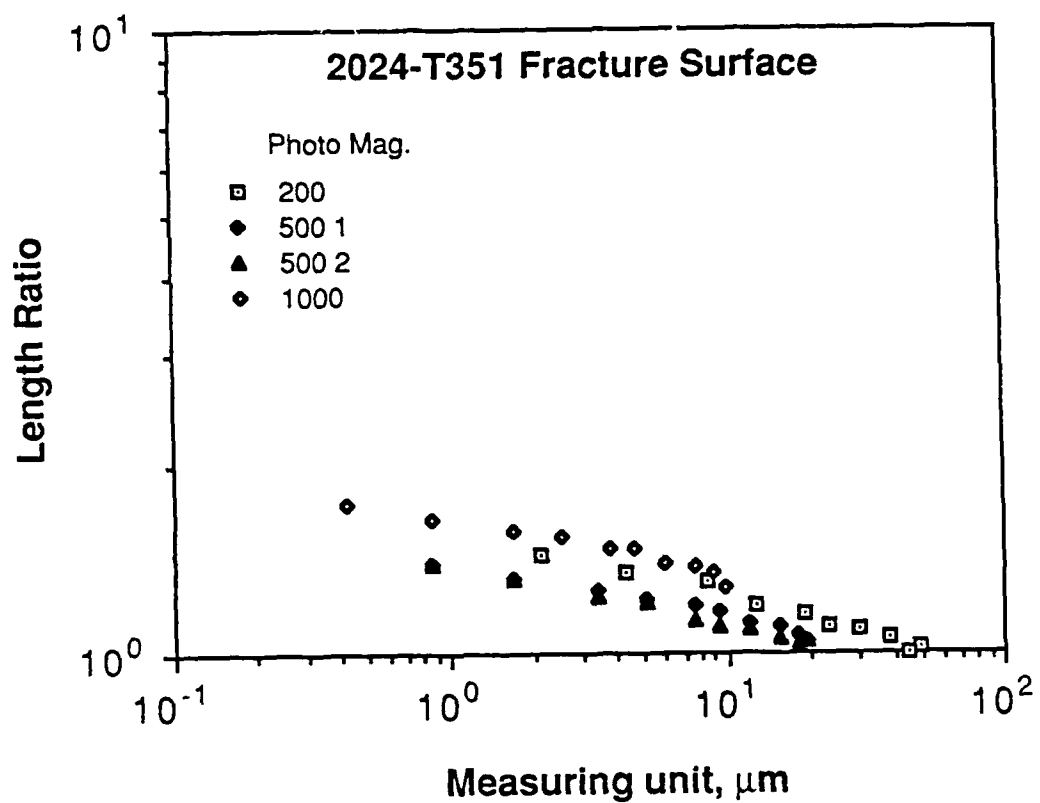
Fig. 4. Comparison of Profile Length Ratio parameters measured at different photographic magnifications.

As indicated in the previous section, all profiles were taken from 200X photographs. What would the effect be if a smaller measuring unit were used? For insight into this issue, photographs of 2024-T351 were taken at 500 and 1000X and analyzed. Values for profile and surface roughness parameters at all magnifications are given in Table 4, as are values of the profile and surface fractals, D_L and D_S . The variation of R_L with η is shown in Fig. 4, where good agreement may be seen for results between the two 500X photographs and between the 200X and the 1000X photograph. Similar results were obtained for R_S . It is concluded that decreasing the value of η from 2.12 (200X) to 0.42 μm (1000X) had no effect on the description of this fracture surface.

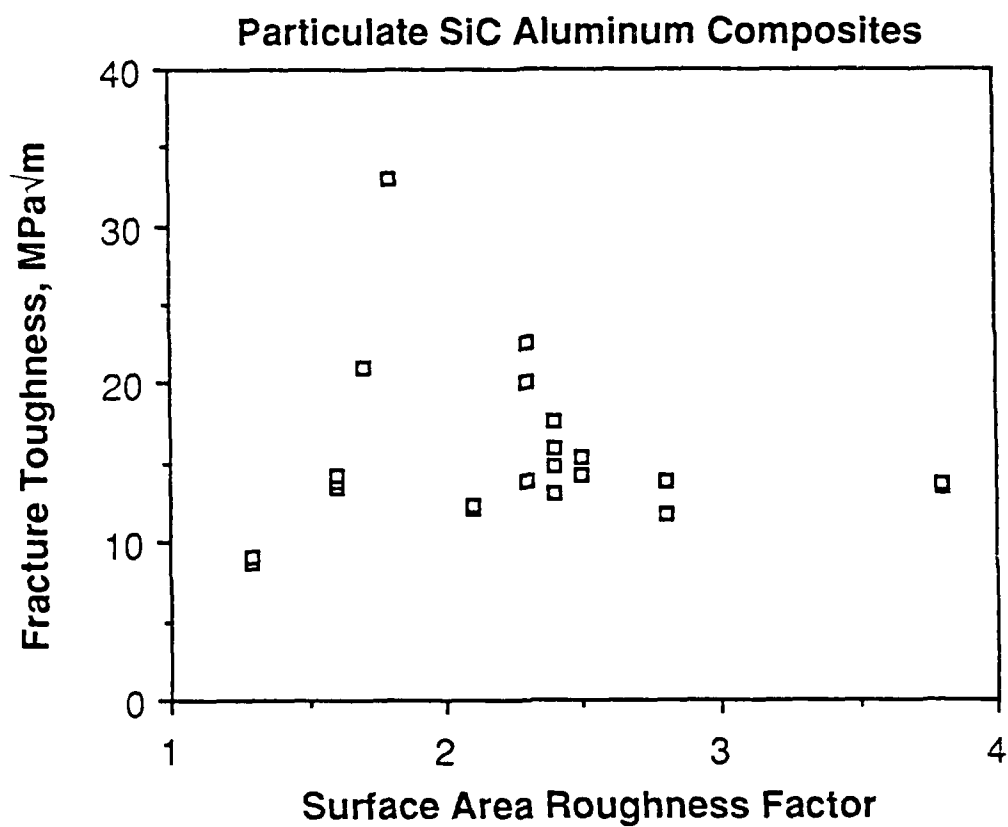
Fig. 5. Comparison of Fracture Toughness and Surface Roughness Ratio for all the composites tested.

The fracture roughness parameters $R_S(0)$ given in Table 5 are compared to the toughness values in Fig. 5. It is appropriate to compare R_S with toughness because it is indicative of the actual surface area of the specimen. There is no discernible correlation between these two material characteristics for these composites. Rather, these data could be construed as indicating the presence of an "optimum roughness" of between 2 and 2.5, which seems to have no physical interpretation.

Fracture Toughness: However, in the context of the present study, the more important question is whether roughness of the fracture surface or the actual surface area correlates with the fracture toughness. In Fig. 5, $R_S(0)$, the surface roughness ratio coefficient, is plotted versus fracture

toughness. There is no obvious correlation. A similar result was found for K_C graffed versus R_L , the profile roughness factor coefficient. These coefficients were used to represent the surface roughness for a common unit of measurement. They are the value of eq. (6) for $n = 1$ and do not represent actual values of profile or surface roughness.

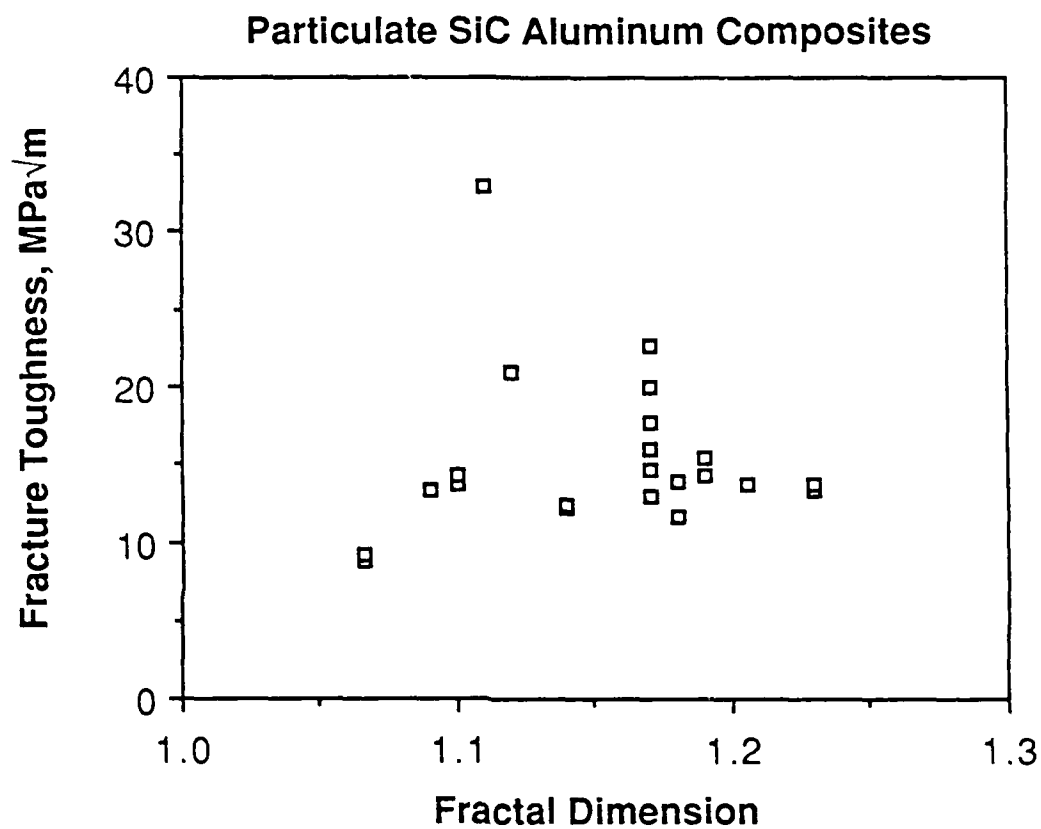
Fig. 6. Comparison of Fracture Toughness and Fractal Dimension derived from the Profile Length Ratio R_L for all the composites tested.

The concept of a relation between fracture toughness and the fractal dimension, (D_L) , is examined in Fig. 6. A similar result was obtained by plotting K_C versus (D_S) . As with profile and surface roughness factor coefficients, there is no correlation between fracture toughness and fractal dimension.
